# FLOOD PLAIN MANAGEMENT STUDY

KASHWITNA RIVER, WASILLA,  
COTTONWOOD, AND LUCILE CREEKS  
ALASKA RIVERS COOPERATIVE STUDY

Susitna River Basin, Talkeetna Subbasin  
Matanuska-Susitna Borough, Alaska

May, 1982

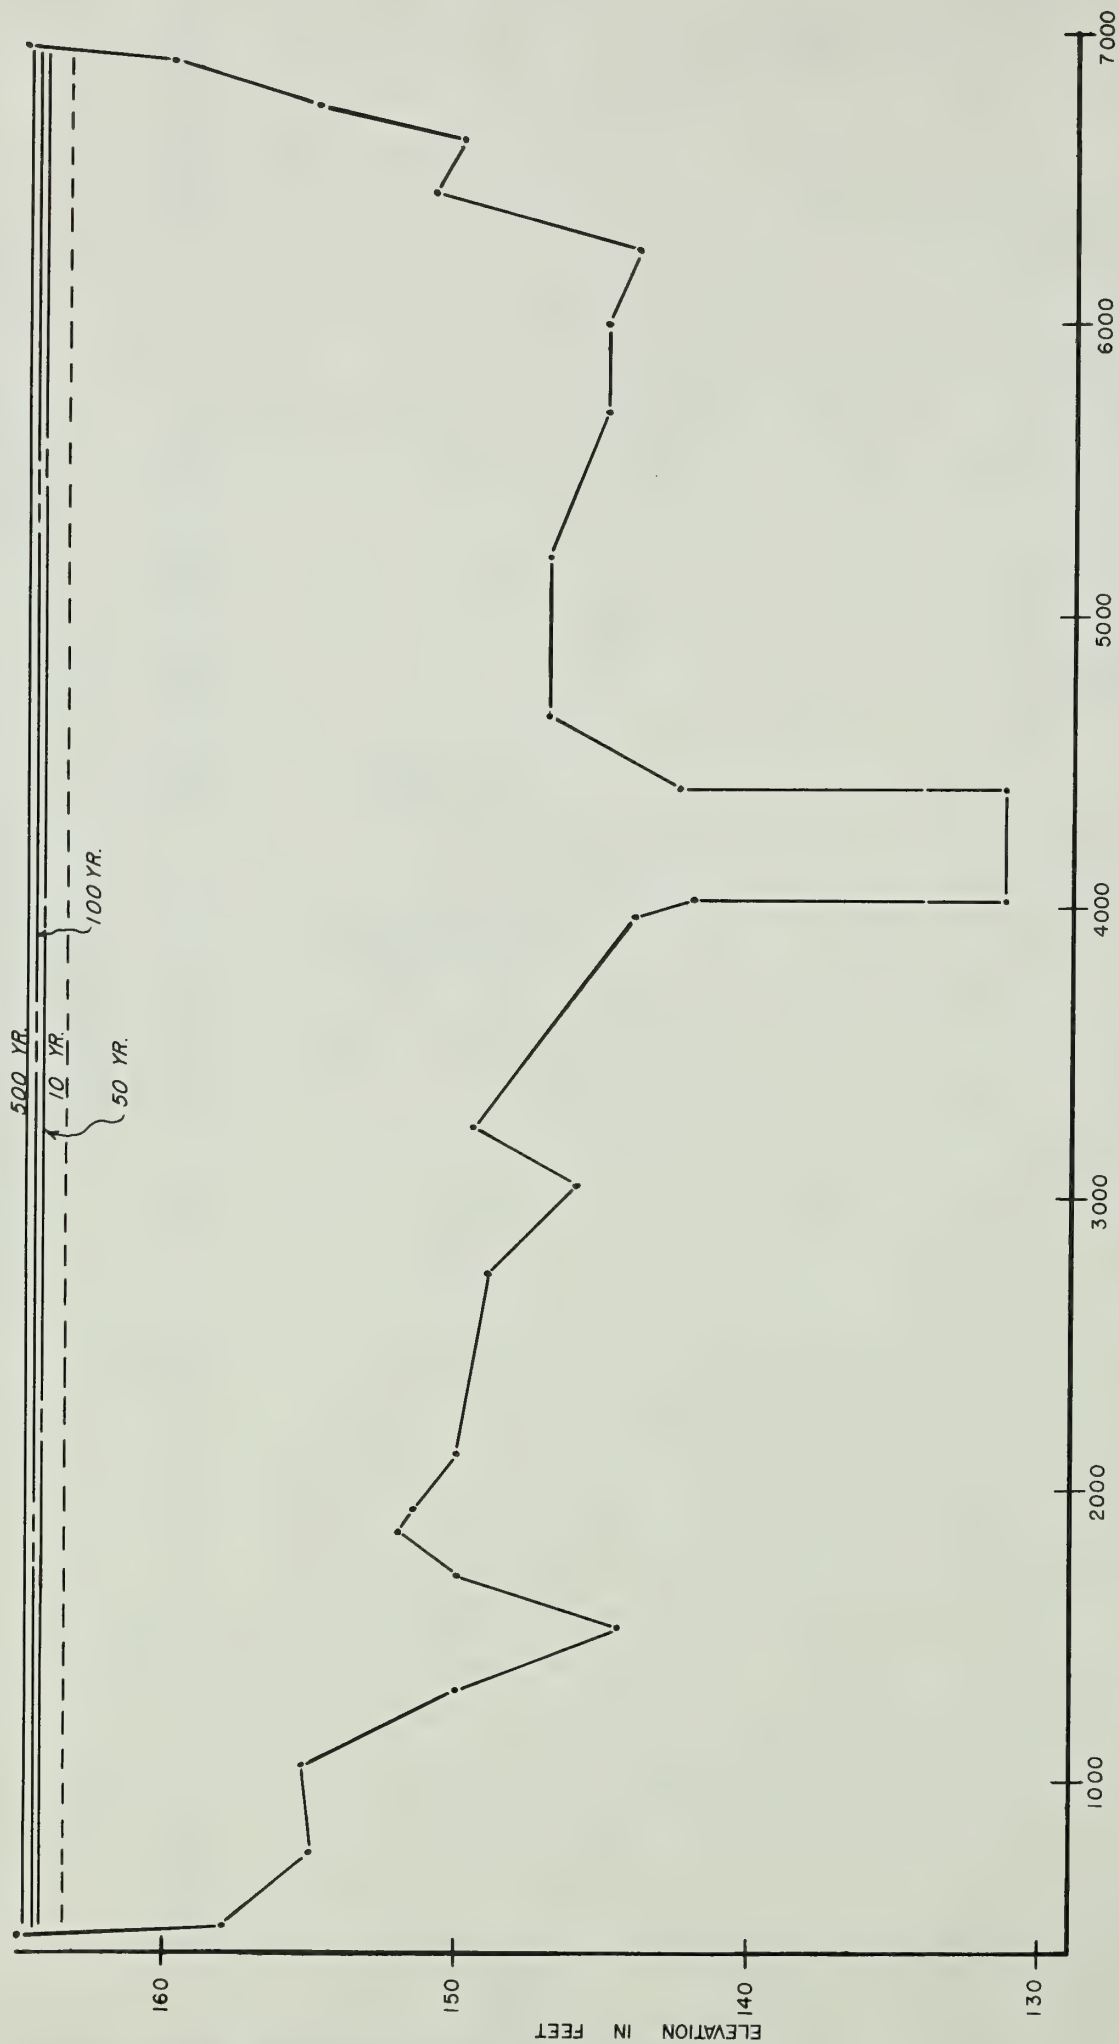
DISTANCE IN FEET  
SECTION K-B  
KASHWITNA RIVER

# TYPICAL VALLEY SECTION PRESENT CONDITION

Figures 2 through 174 are drawings of selected valley cross sections showing the flood elevations under present land use conditions for the 10-, 50-, 100-, and 500-year flood events.

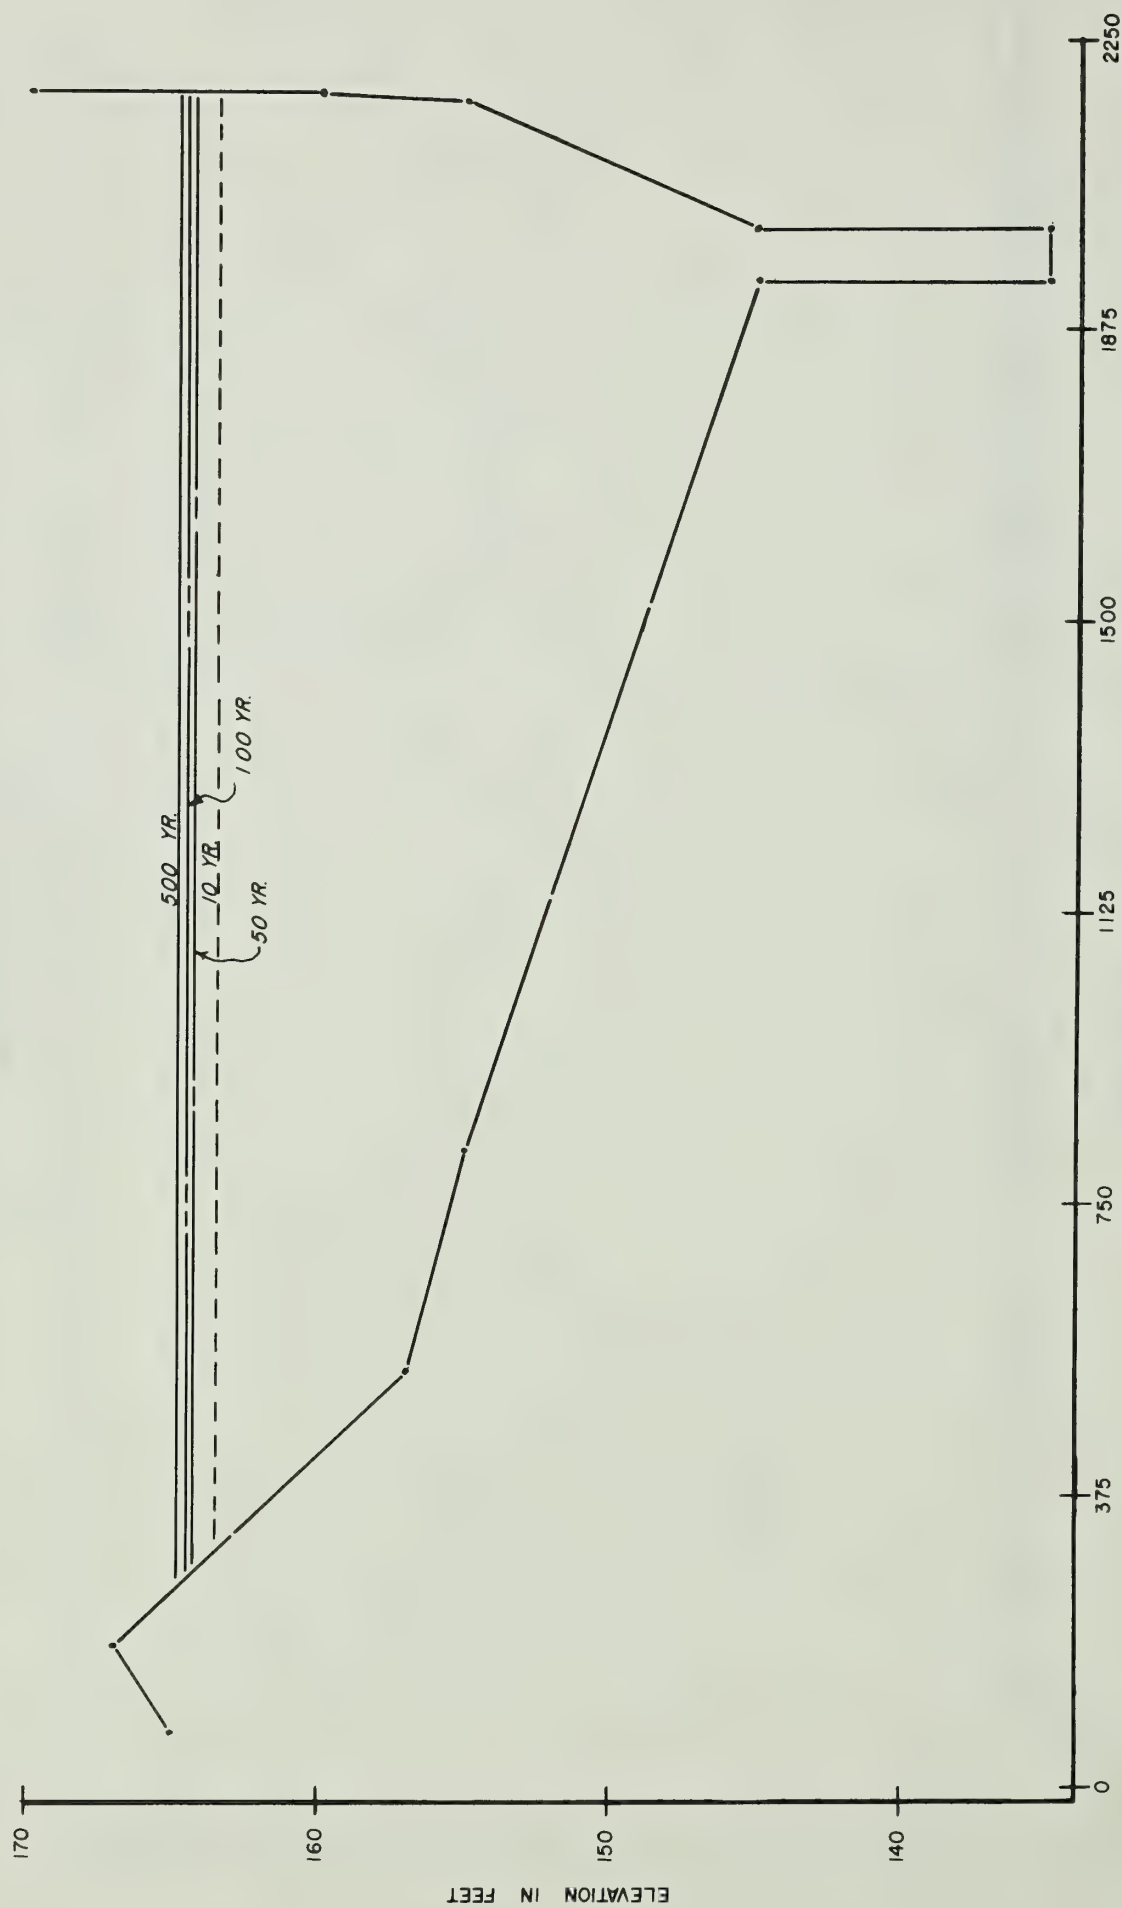
DISTANCE IN FEET  
SECTION K-D  
KASHWITNA RIVER

# TYPICAL VALLEY SECTION PRESENT CONDITIONS

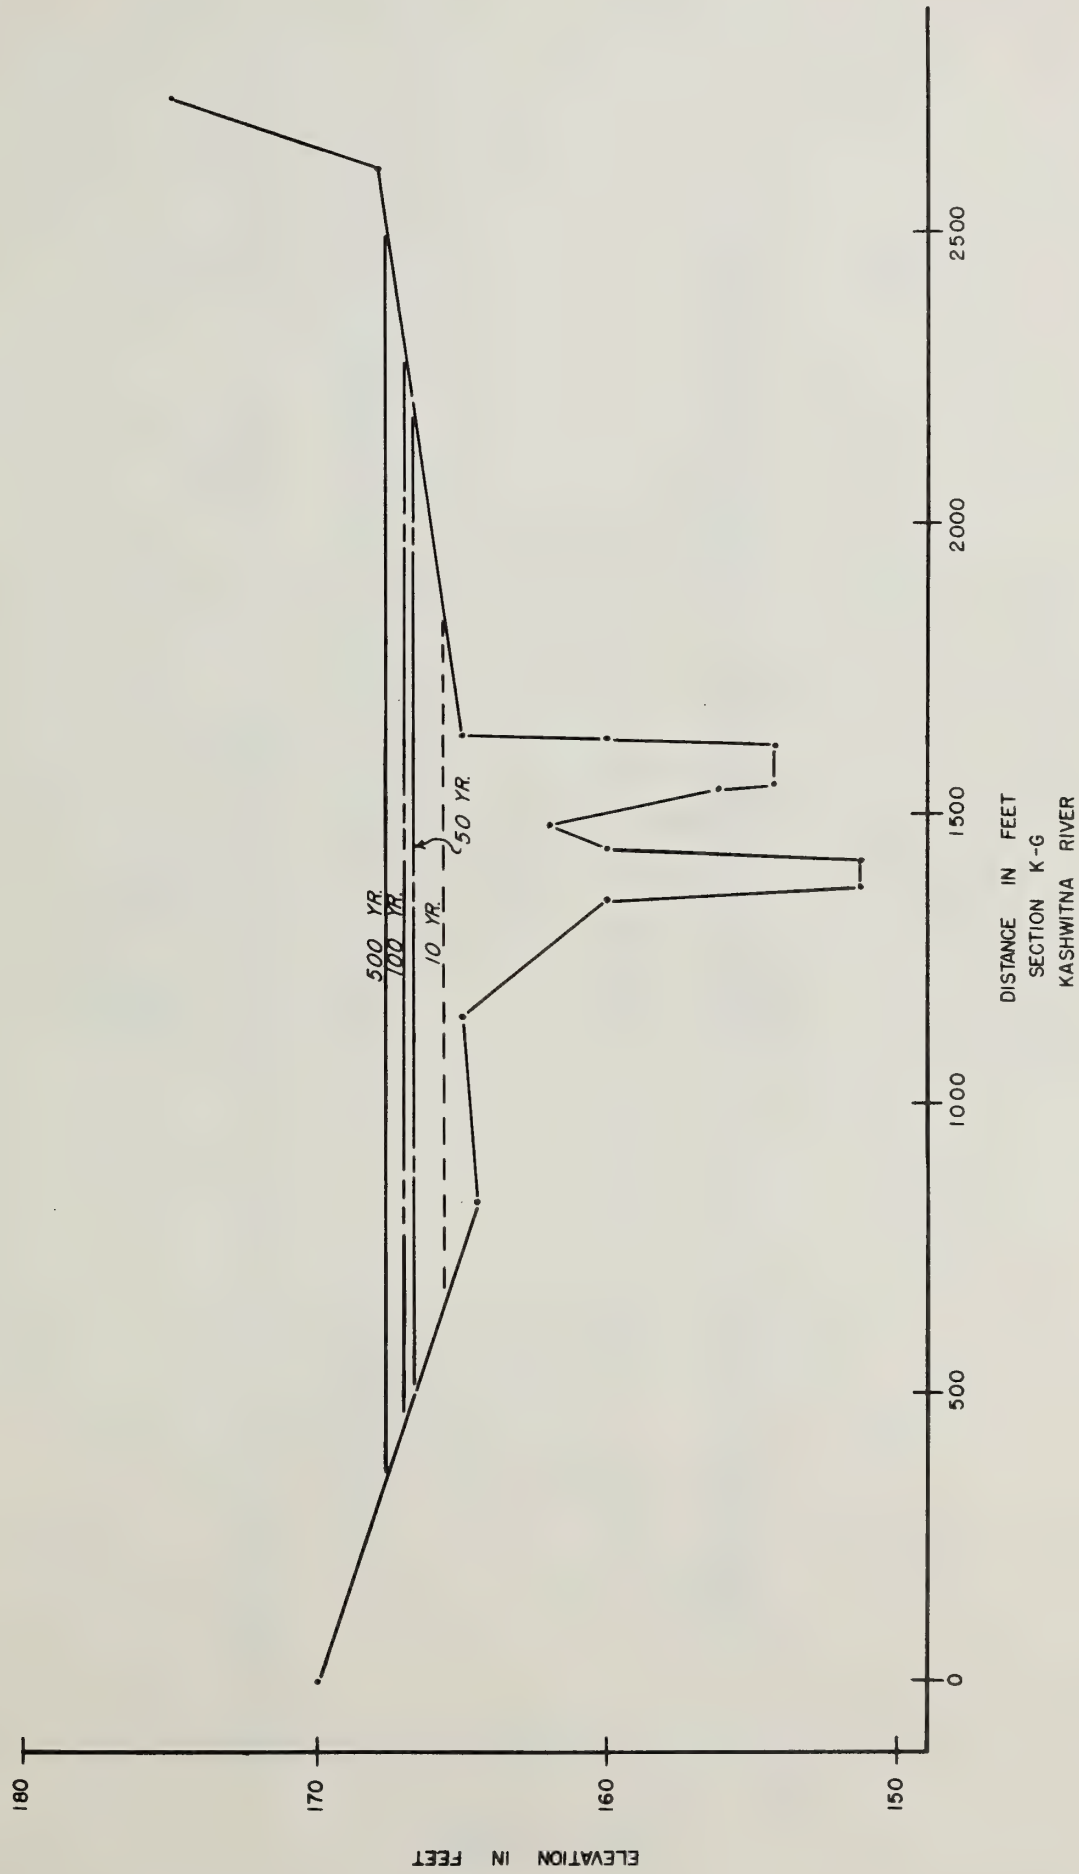
SOIL CONSERVATION SERVICE  
U.S. DEPARTMENT OF AGRICULTURE  
TALKEETNA SUBBASIN  
MATANUSKA - SUSITNA BOROUGH, ALASKA  
FIGURE 8

# TYPICAL VALLEY SECTION PRESENT CONDITIONS

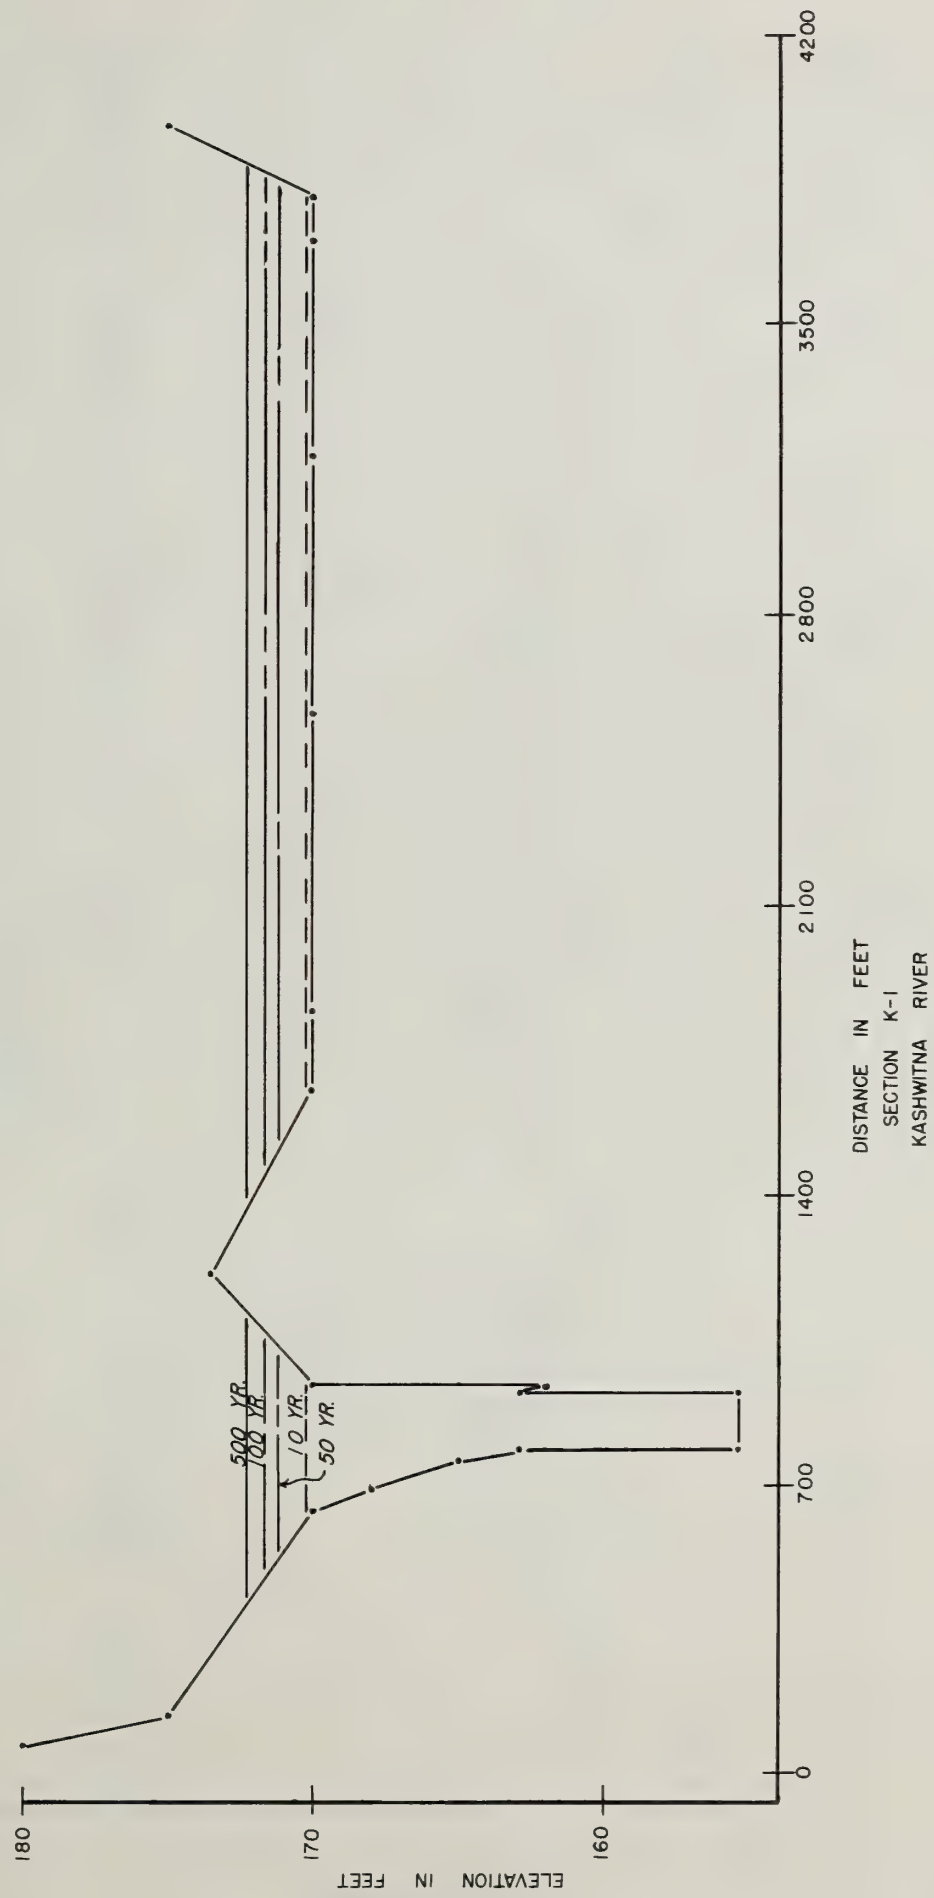
Cross-section diagram of Section K-J, KASHWITNA RIVER. The vertical axis represents ELEVATION IN FEET (160 to 180), and the horizontal axis represents DISTANCE IN FEET (0 to 3000). The diagram shows a profile line and a cross-section of the river channel. The cross-section is divided into four horizontal layers labeled 500 YR., 100 YR., 10 YR., and 50 YR. The profile line shows a significant drop in elevation around 1000 feet distance, corresponding to the river channel.

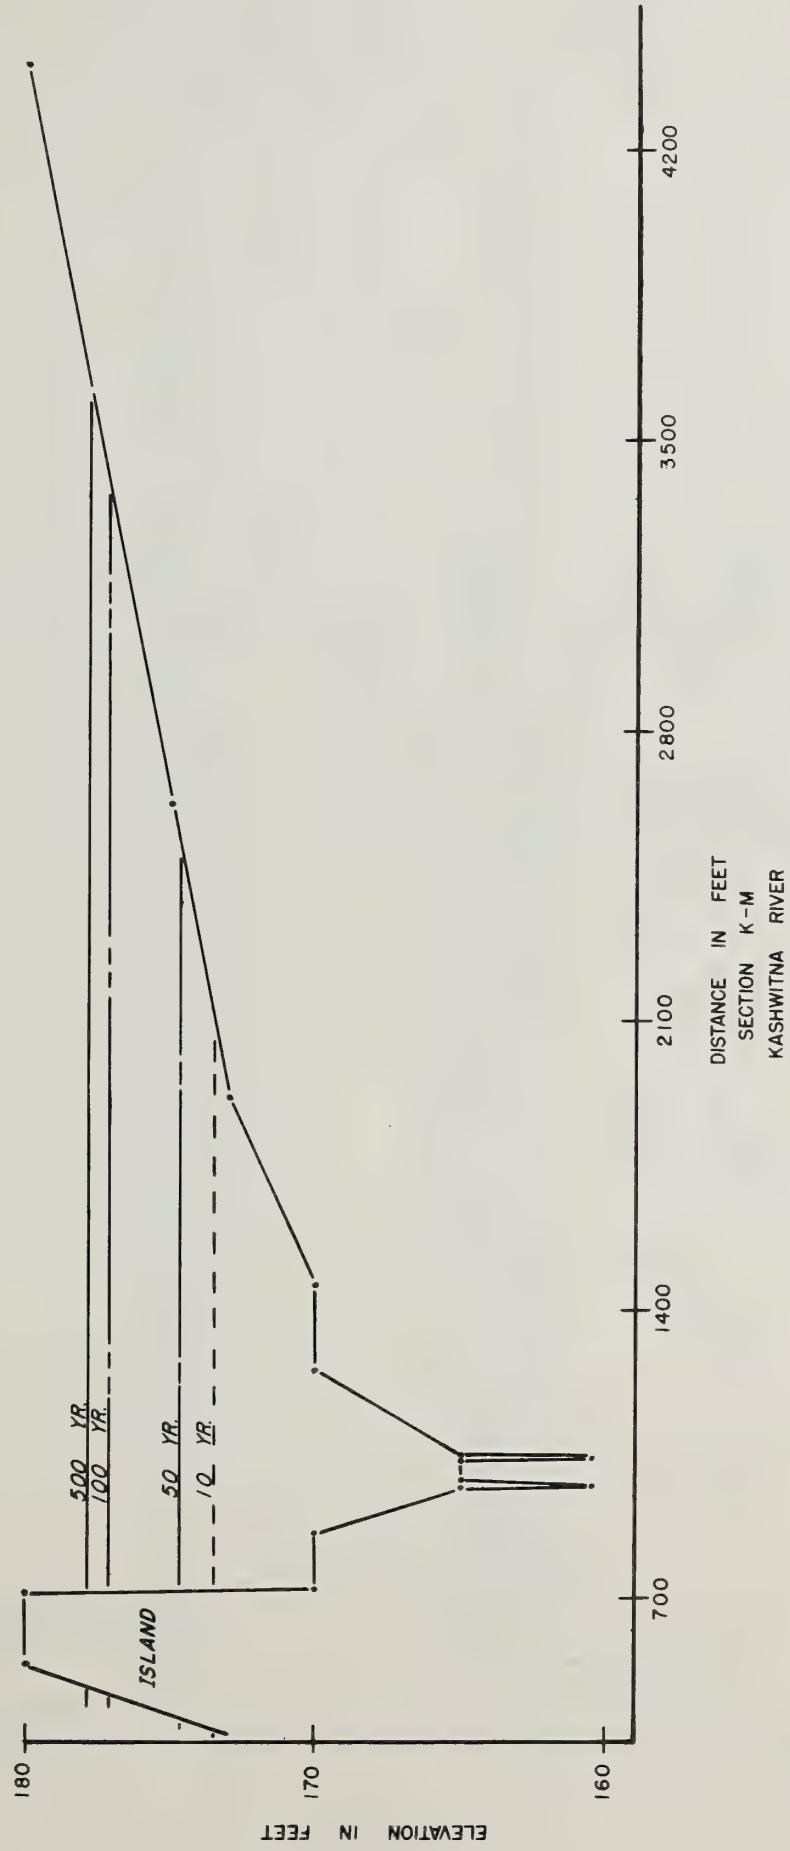
SOIL CONSERVATION SERVICE  
U.S. DEPARTMENT OF AGRICULTURE  
TALKEETNA SUBBASIN  
MATANUSKA-SUSITNA BOROUGH, ALASKA  
FIGURE 14

# TYPICAL VALLEY SECTION PRESENT CONDITIONS

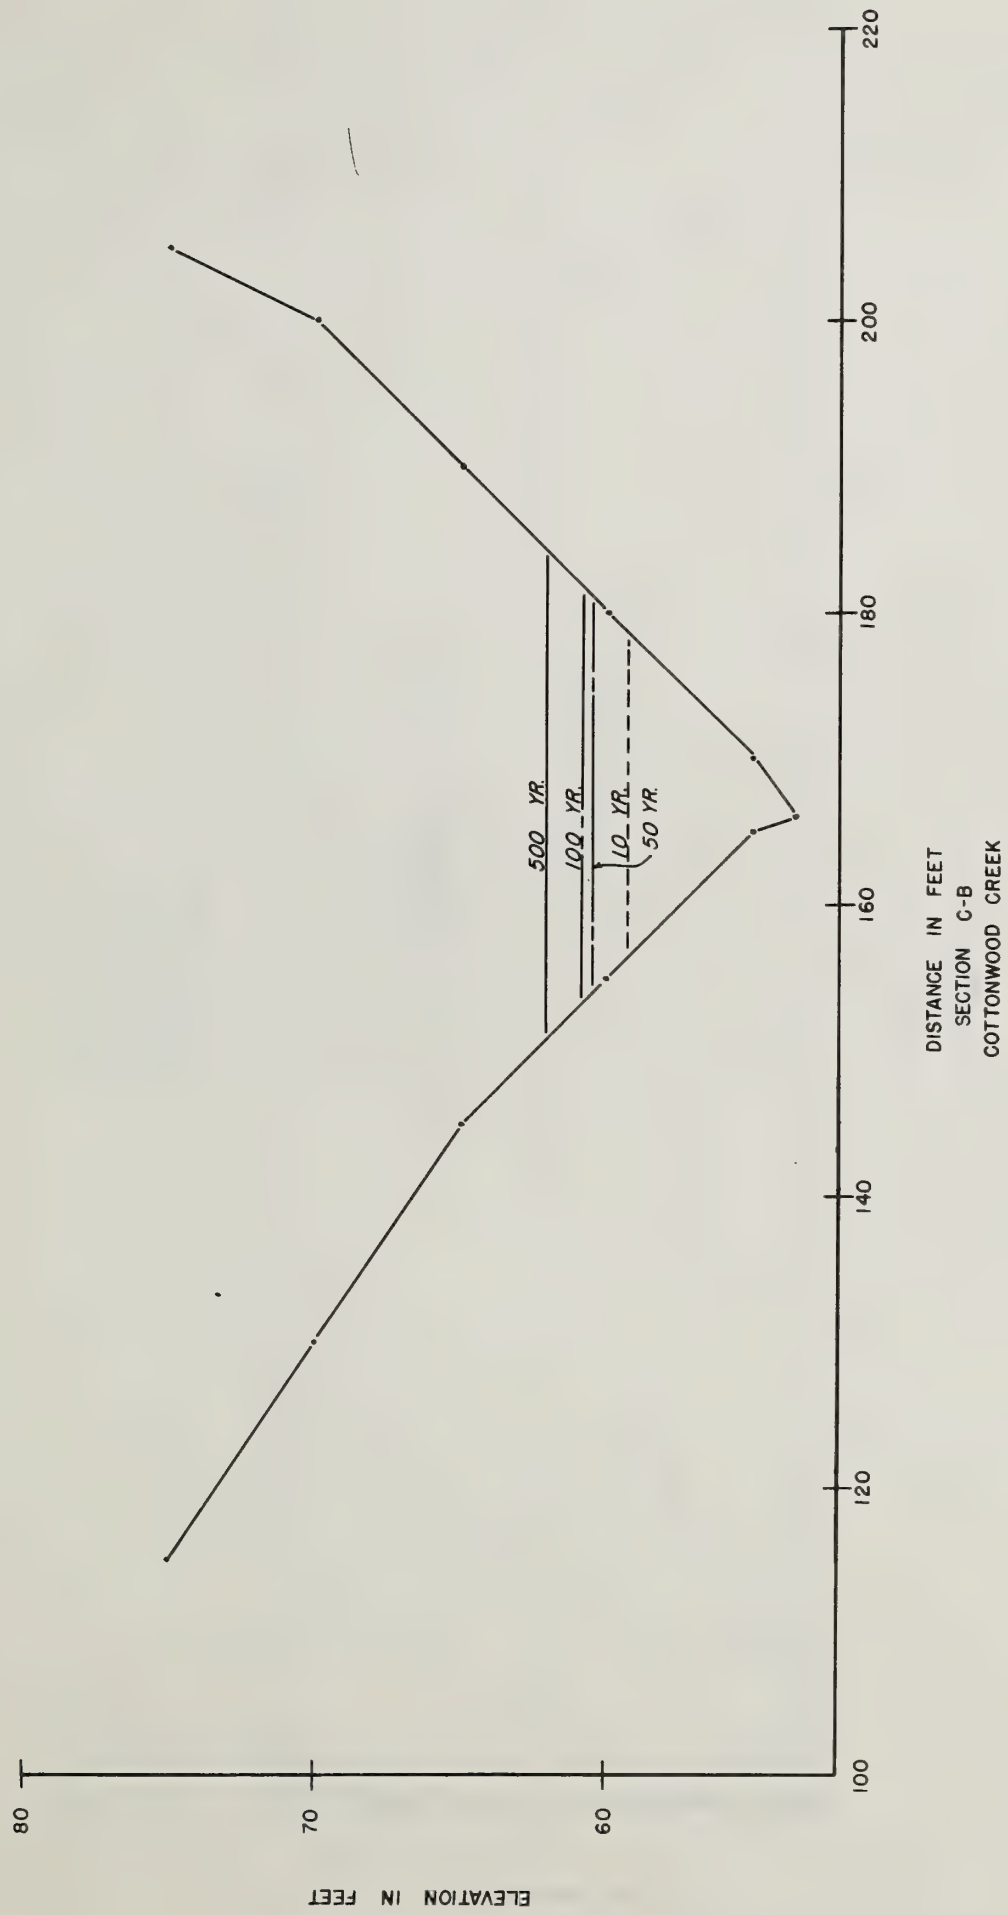
FIGURE 28

TYPICAL VALLEY SECTION  
PRESENT CONDITIONS

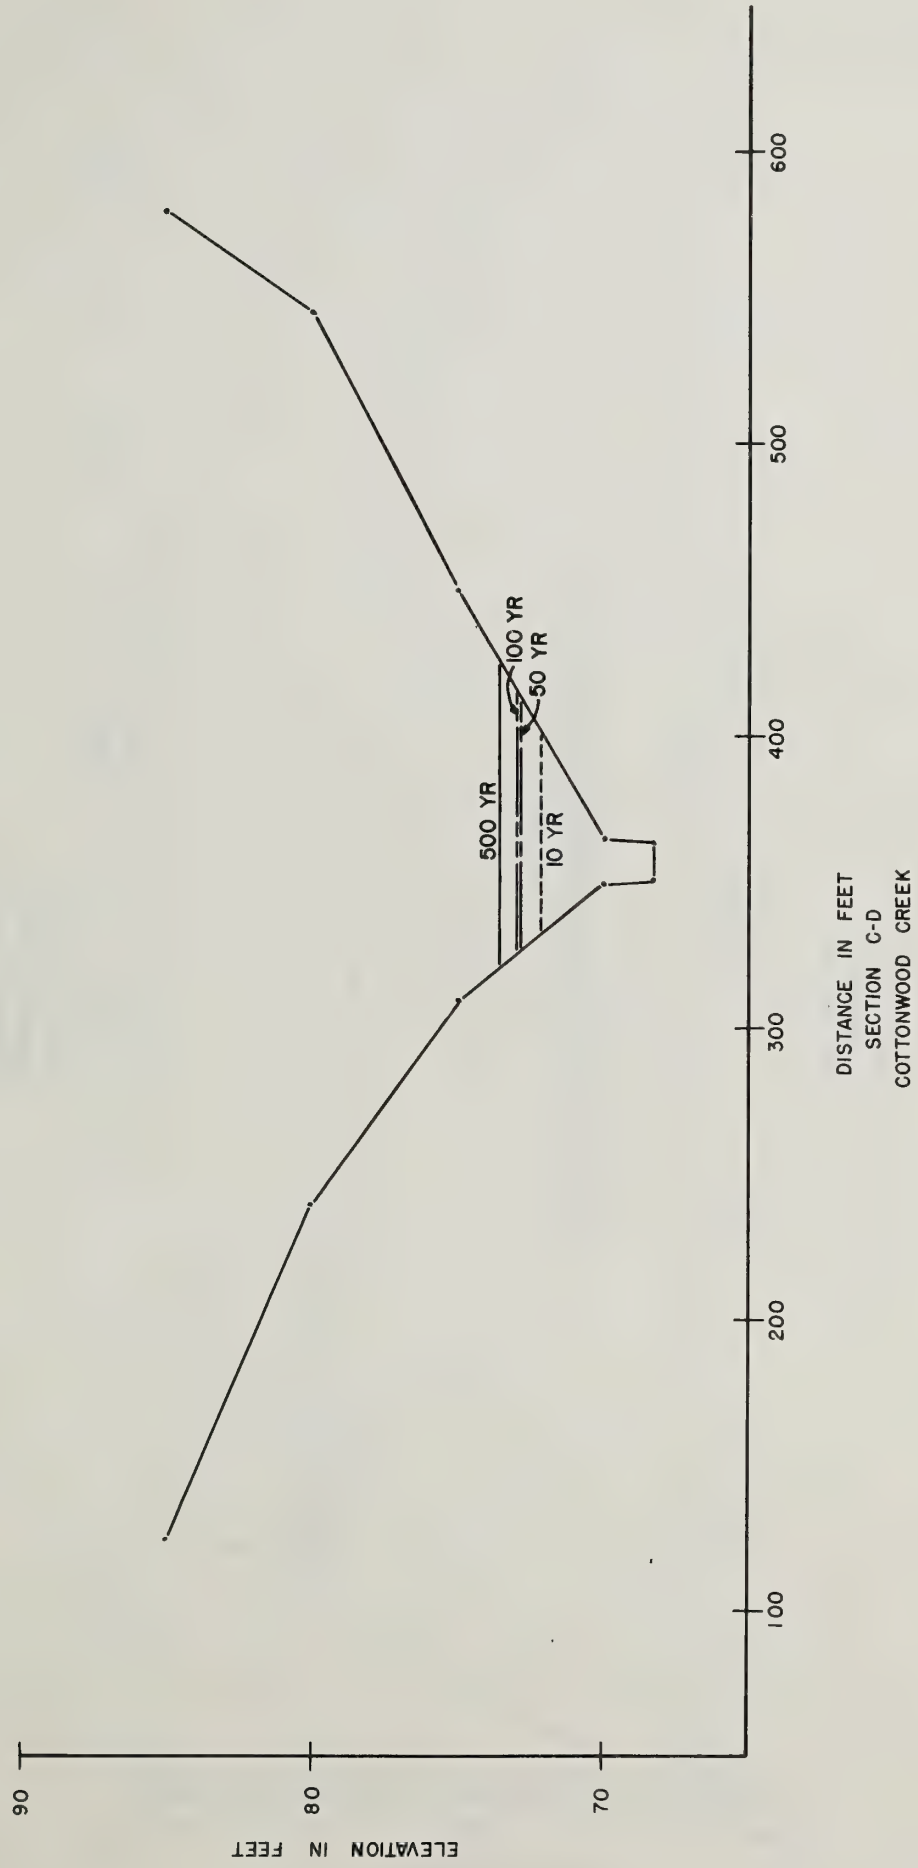
FIGURE 30

TYPICAL VALLEY SECTION  
PRESENT CONDITIONS

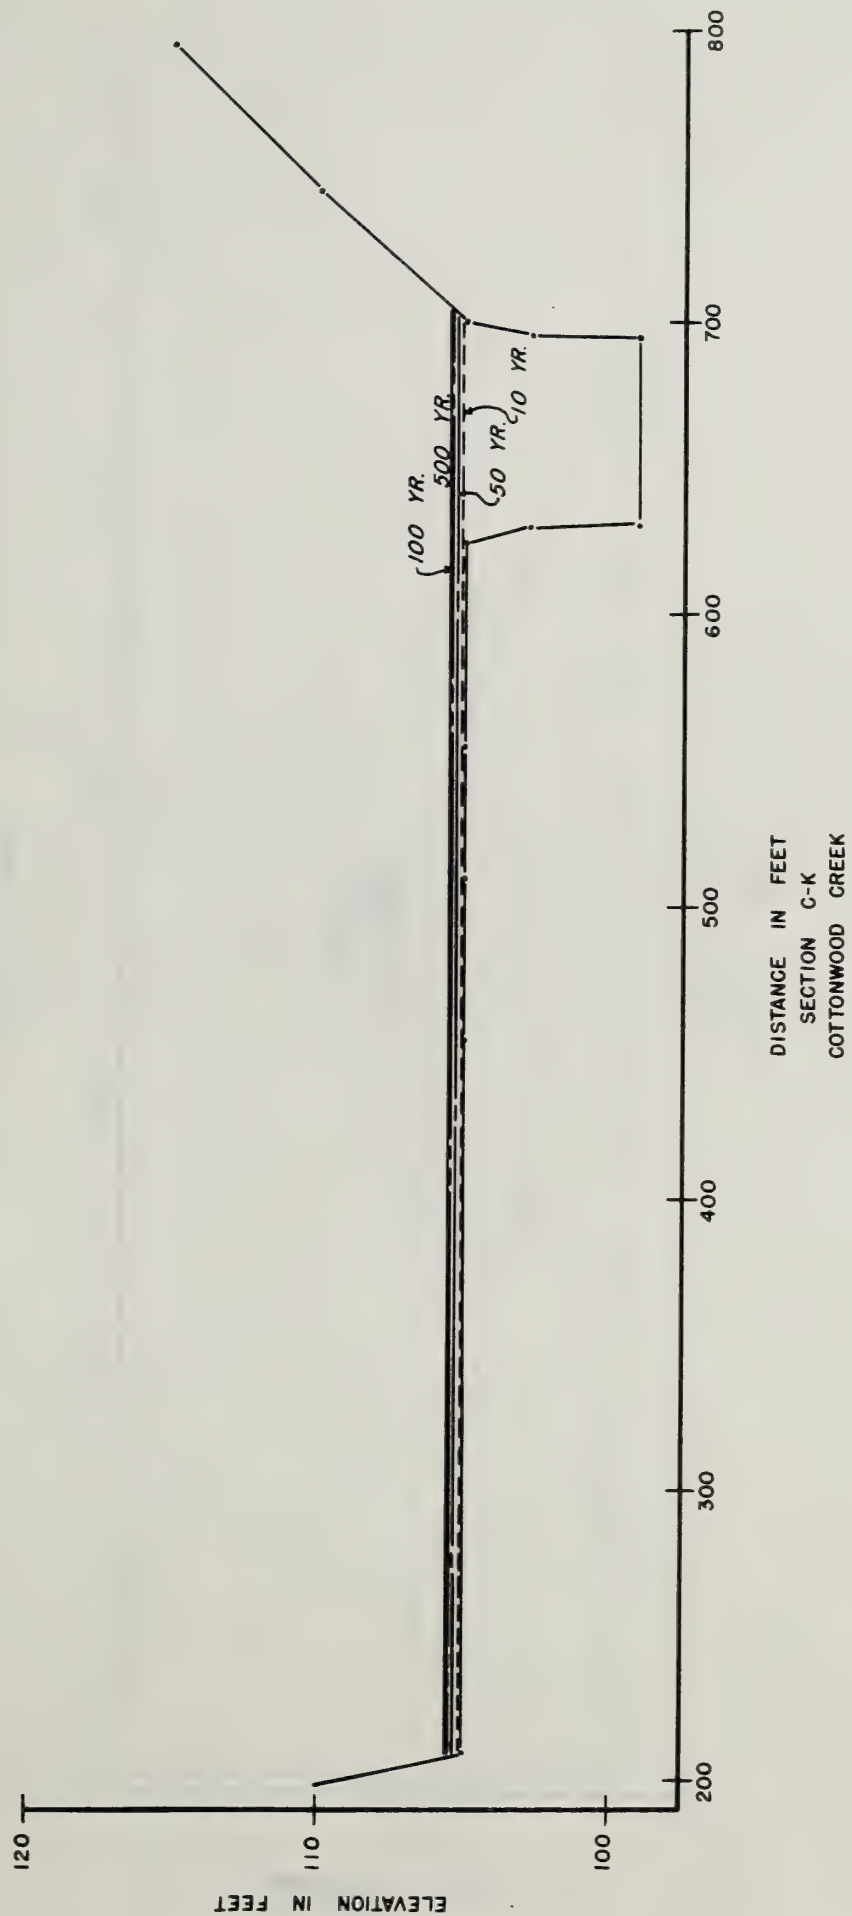
FIGURE 36

TYPICAL VALLEY SECTION  
PRESENT CONDITIONS

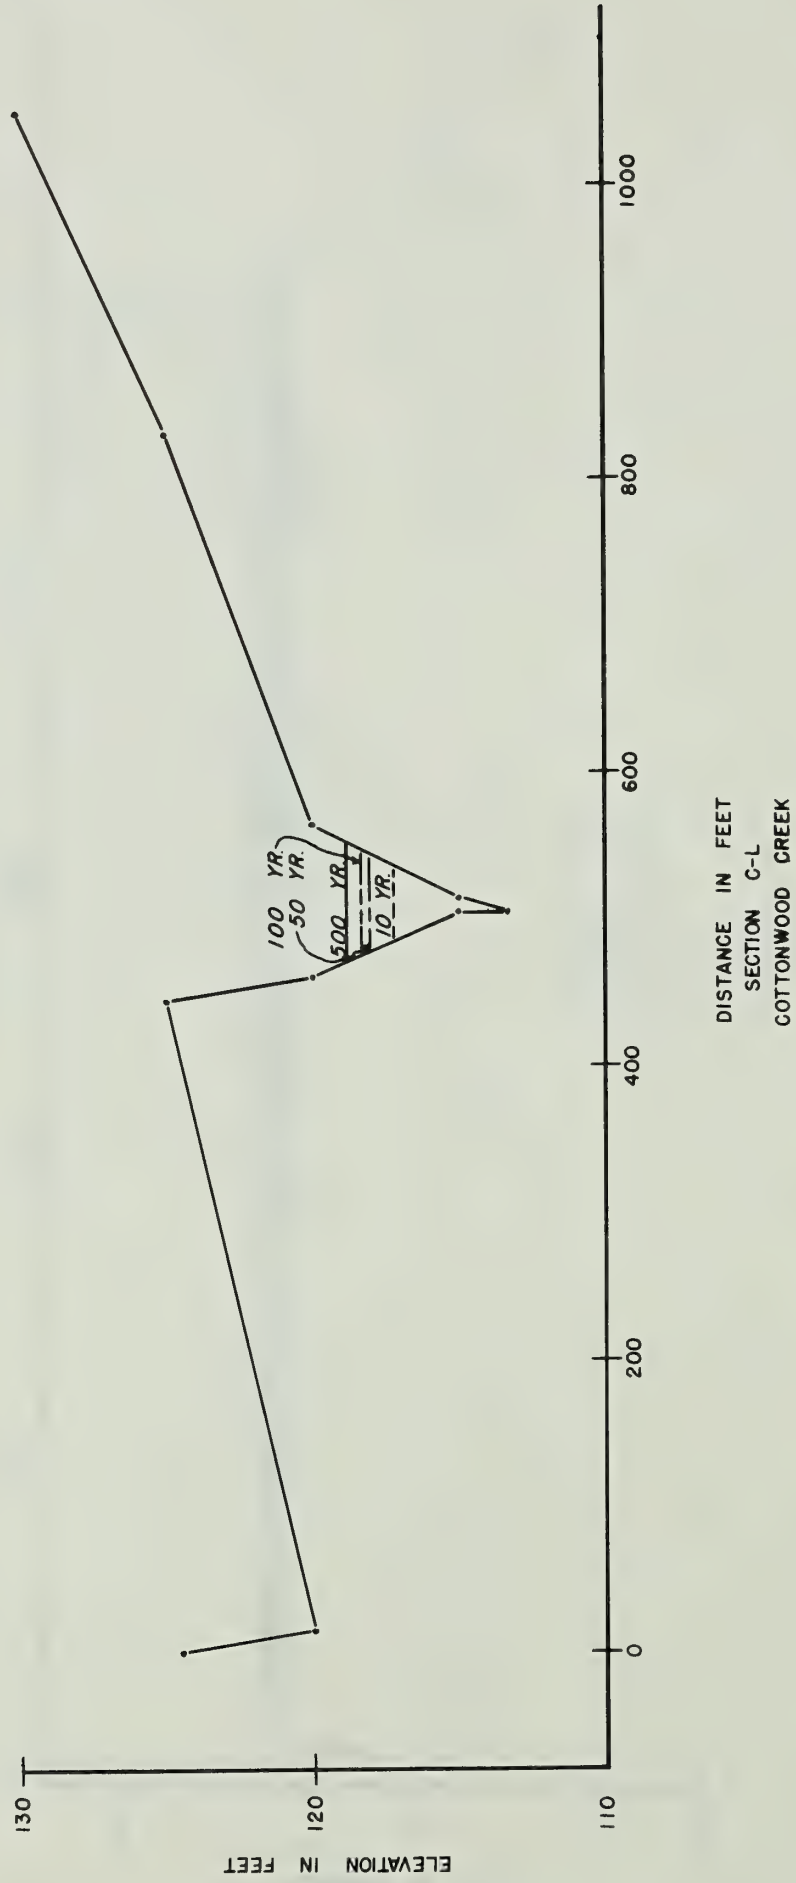
FIGURE 37

# TYPICAL VALLEY SECTION PRESENT CONDITIONS

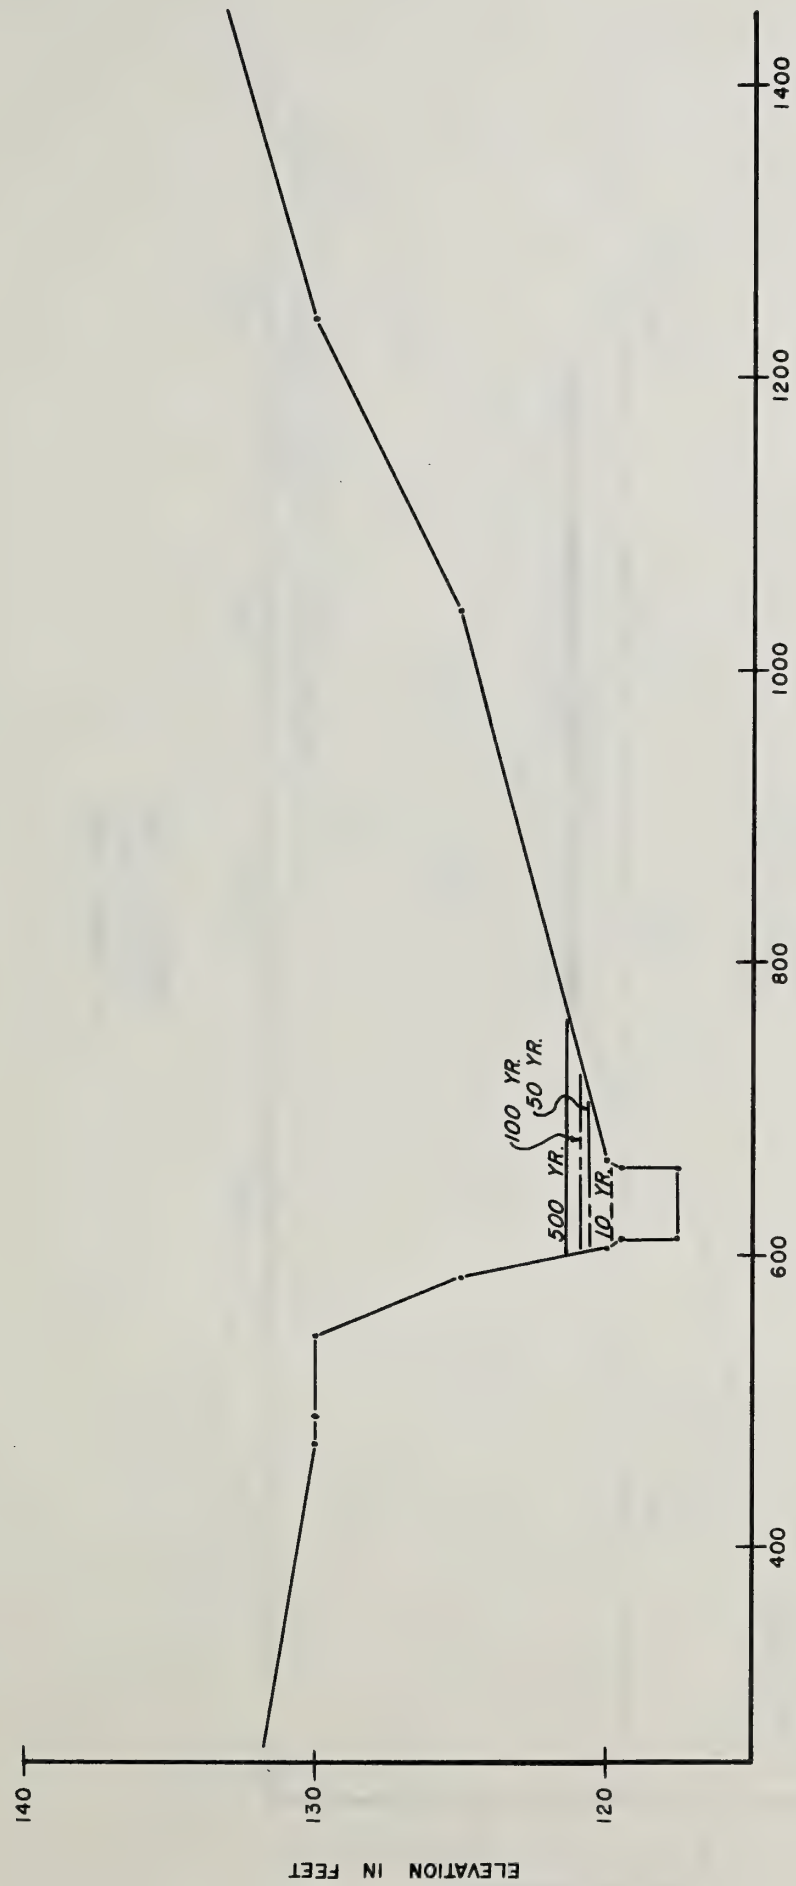
DISTANCE IN FEET  
SECTION C-M  
COTTONWOOD CREEK

# TYPICAL VALLEY SECTION PRESENT CONDITIONS

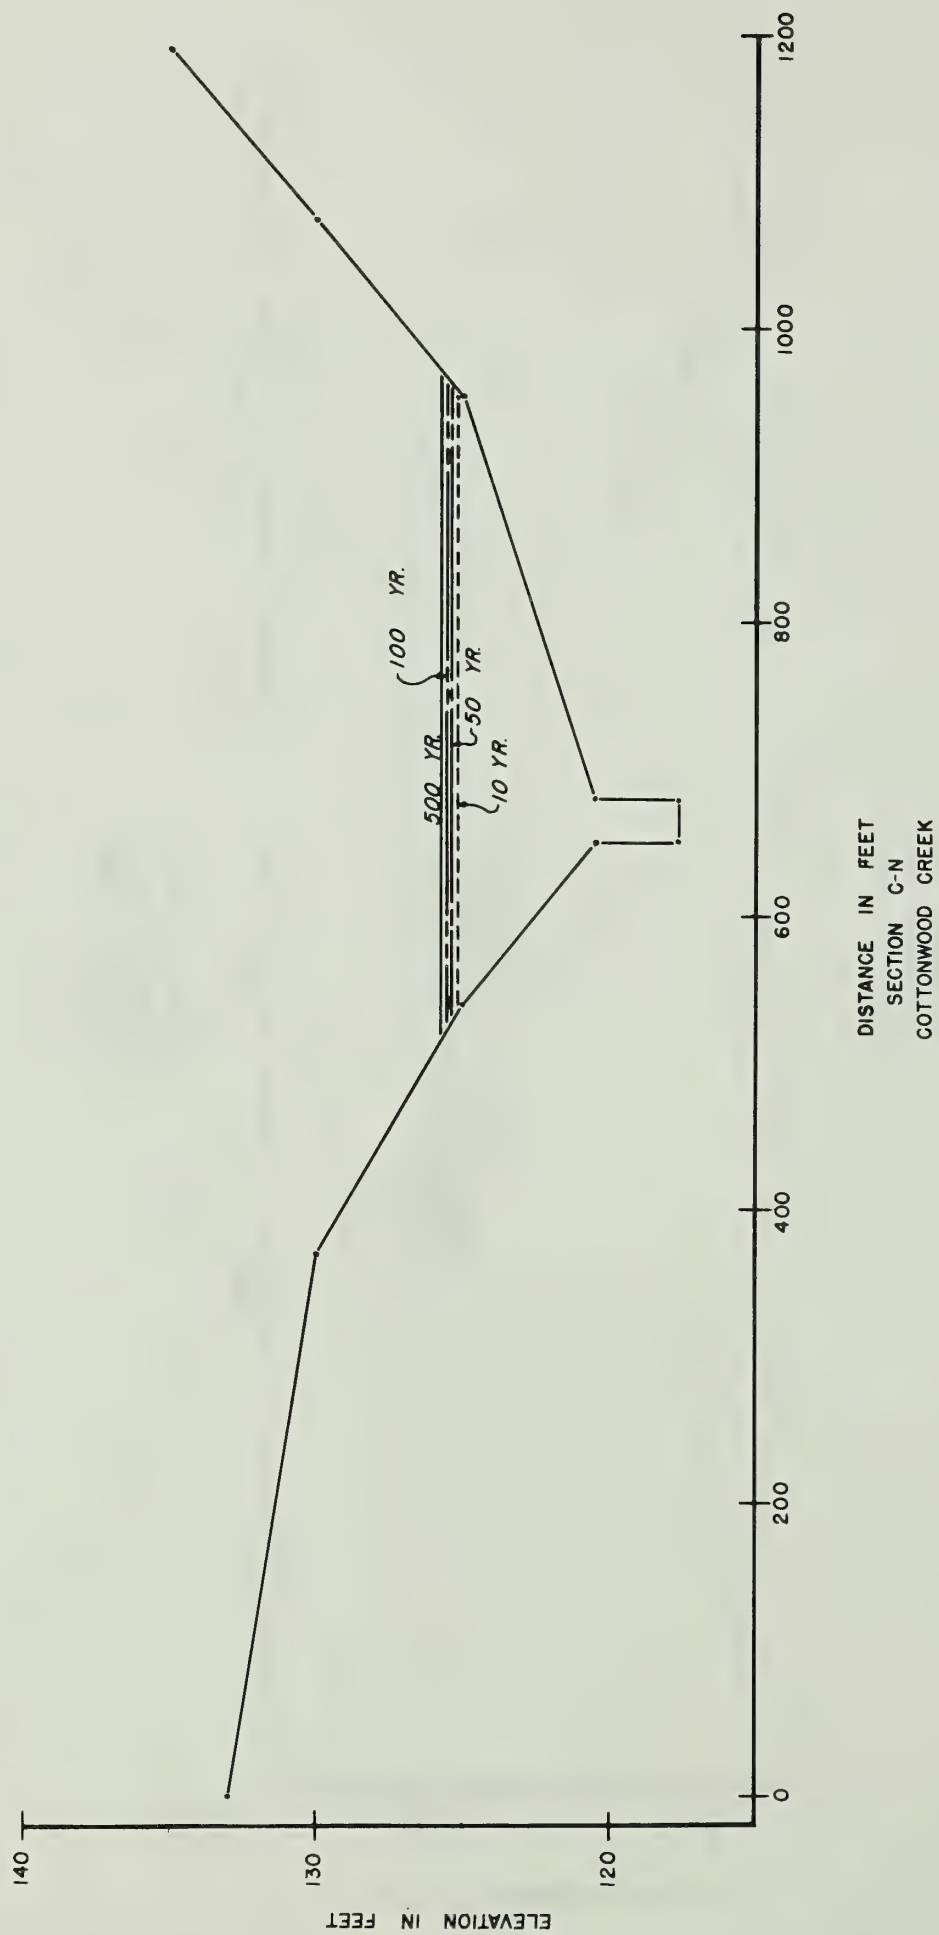
FIGURE 39

# TYPICAL VALLEY SECTION PRESENT CONDITIONS

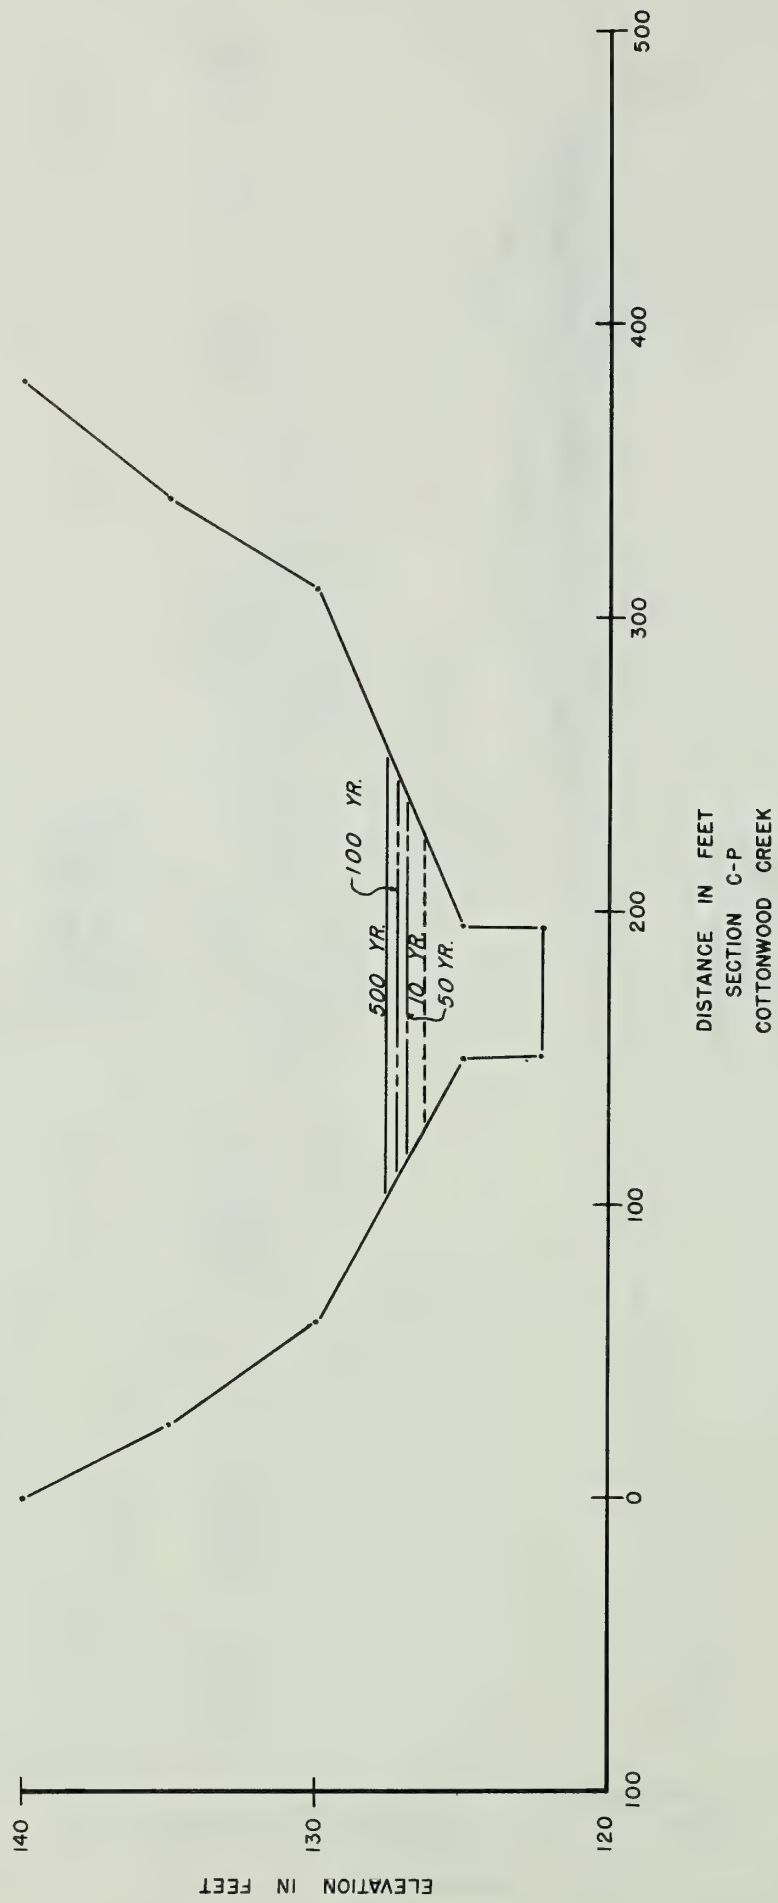
FIGURE 41

# TYPICAL VALLEY SECTION PRESENT CONDITIONS
